Report of Marine Survey  
Of a 1992 Luhrs T300 Motor Vessel

John N. Allinson, II  
INDEPENDENT MARINE CONSULTANT  
AND SAMS® ACCREDITED MARINE SURVEYOR

File Number	2001-04-20-01
Survey Prepared for:	<b>CLIENT</b>
Name of Vessel:	NOT NAMED
Type of Survey:	<b>Pre-Purchase Survey</b>
** Overall Vessel Rating:	<b>"Above BUC â Condition"</b> Has had above average care and equipped with extra electrical and electronic gear.

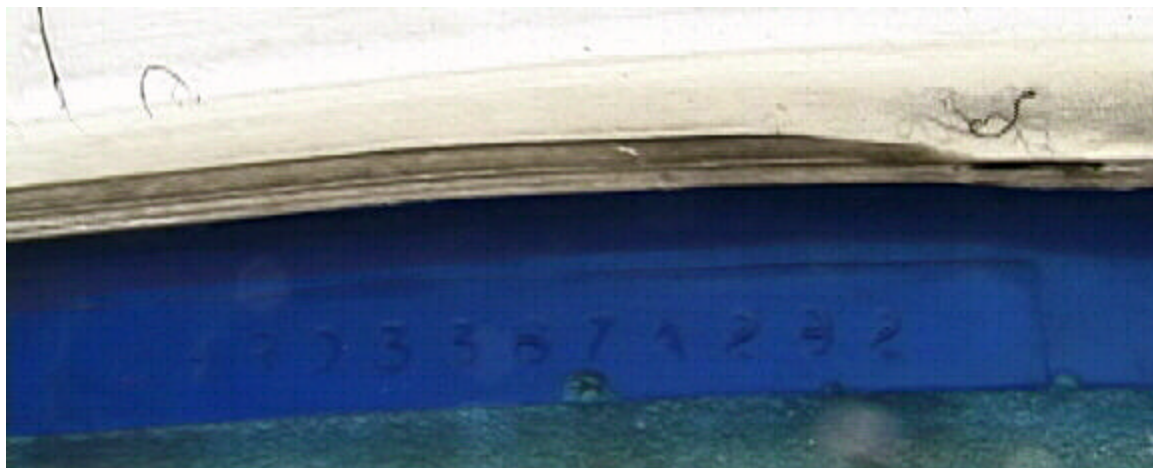
Digital photograph of HIN. Note that its indentations are just legible.

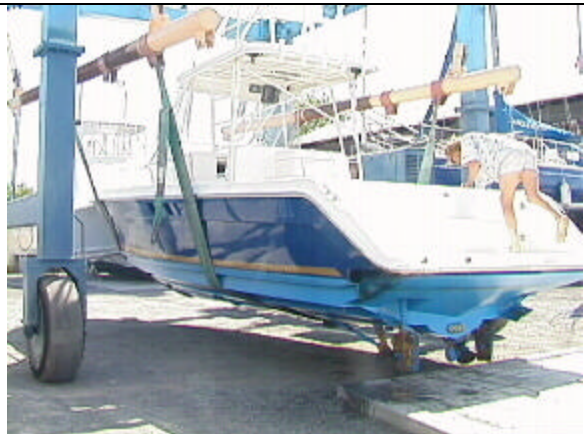
Port view of stern and side of boat being hauled at Oasis Marina. Note placement of slings. Note underwater running gear; drive shafts, struts, propellers, rudders, exhaust ports, trim tabs.

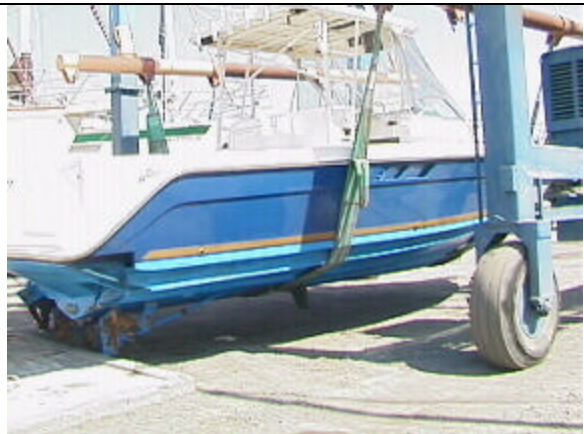
Starboard view of stern and side of boat being hauled at Oasis Marina. Note placement of slings, natural ventilation for engines.

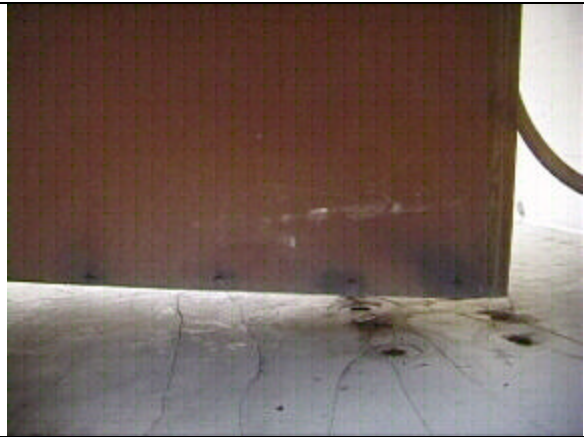
Damaged flooring under the bait station.

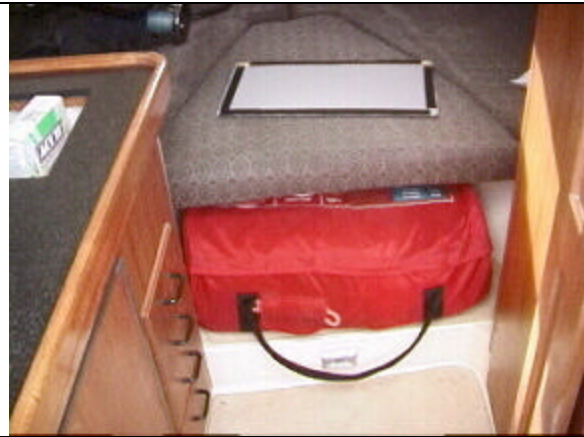
Eight (8) person life raft in the main cabin underneath the forward V berth.

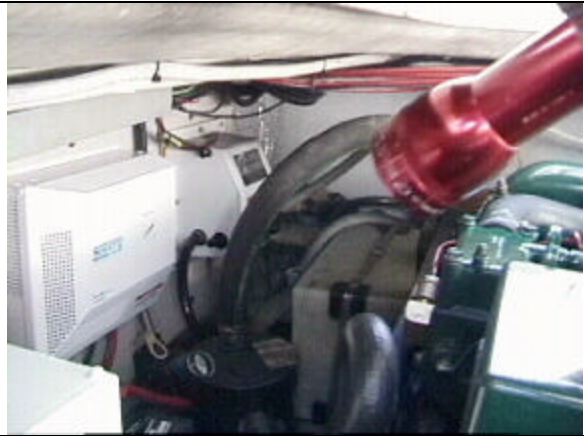
View of forward starboard area in engine compartment. Note Air Conditioning electrical relay box, oil changing box, plastic holding tank.

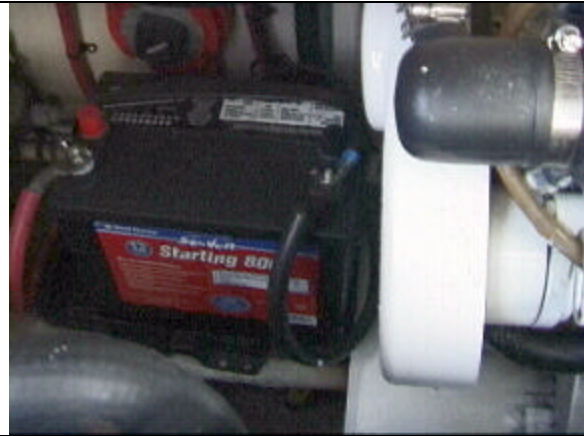
View of forward port area in engine compartment. Note unsecured starting battery for generator. Battery selector switch and single connections to the battery terminal.

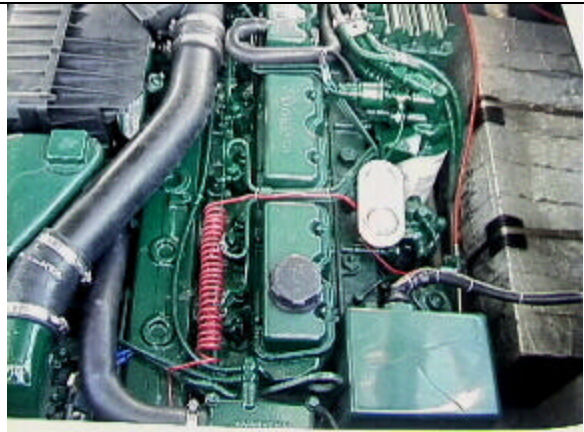
View of the port engine. Front 2 fuel injectors were leaking a small amount of diesel fuel. Silver manual temperature and pressure gauge has moisture behind the lens and gauge can't be read. Note secured rectangular water tank on the right side of photo.

Recommendation:	Have fuel injectors checked. Determine the cause of squeal and have it fixed.
Reference: B5	<b>*B5 GOOD CONDITION</b> port side showed no signs of play while starboard side showed just a slight movement. Both shafts turned easily through the struts.
Recommendation:	Monitor cutlass bearings and replace when they allow shaft play.
Reference: B6	<b>*B6 Appear to be in GOOD CONDITION</b> Batteries were not load tested. Port battery was not secured. Starboard battery is not large enough to handle sustained house power drain. Generator will need to be run in order to supply recharging power.
Recommendation:	Consider installing larger battery for house power. Consider installing a solar panel to trickle charge the starter battery when the boat is out on the mooring and not in use.
Reference: B7	<b>*B7 GOOD CONDITION</b> Note that the shower pan in the head has stress cracks in it.
Recommendation:	Grind out fiberglass cracks and fix with FRP.

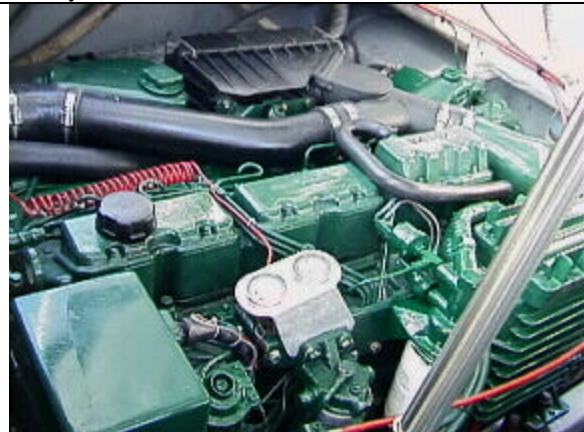
View of starboard engine. Silver manual temperature and pressure gauge has moisture behind the lens and gauge can't be read

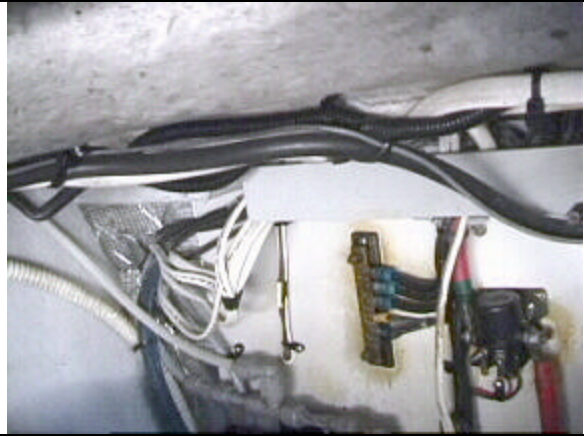
Typical view of electrical wiring support throughout boat.

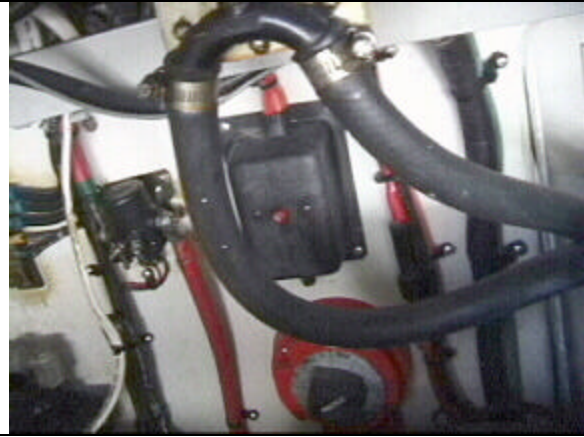
View of port side forward bulkhead in engine room. Note siphon break for generator, solenoid for starting generator, fuse box and battery selector.
