Report of Marine Survey  
Of a 1992 Luhrs T300 Motor Vessel

John N. Allinson, II  
INDEPENDENT MARINE CONSULTANT  
AND SAMS® ACCREDITED MARINE SURVEYOR

File Number	2001-04-20-01
Survey Prepared for:	<b>CLIENT</b>
Name of Vessel:	NOT NAMED
Type of Survey:	<b>Pre-Purchase Survey</b>
** Overall Vessel Rating:	<b>"Above BUC â Condition"</b> Has had above average care and equipped with extra electrical and electronic gear.

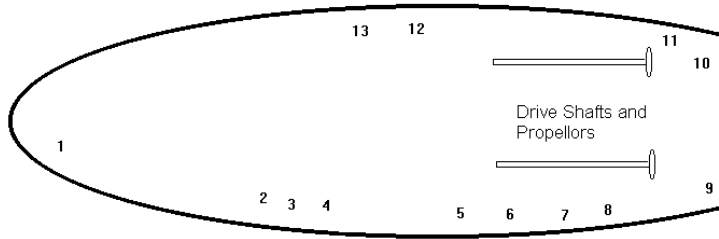
### Above Waterline

LOCATION	USE	MATERIAL	COMMENTS
1	Chain locker	Fiberglass	GOOD CONDITION
2	AC discharge	Plastic	GOOD CONDITION
3	Forward bilge	Plastic	GOOD CONDITION
4	Galley sink	Plastic	GOOD CONDITION
5	Bait Station Drain	Plastic	GOOD CONDITION
6	Deck drain	Plastic	GOOD CONDITION
7	Live well drain	Plastic	GOOD CONDITION
8	Deck drain	Plastic	GOOD CONDITION
9,10	Engine Exhausts	Fiberglass	GOOD CONDITION
11	Deck Drain	Plastic	GOOD CONDITION
12	Generator Exhaust	Metal/Fiberglass	GOOD CONDITION
13	Head sink drain	Plastic	GOOD CONDITION

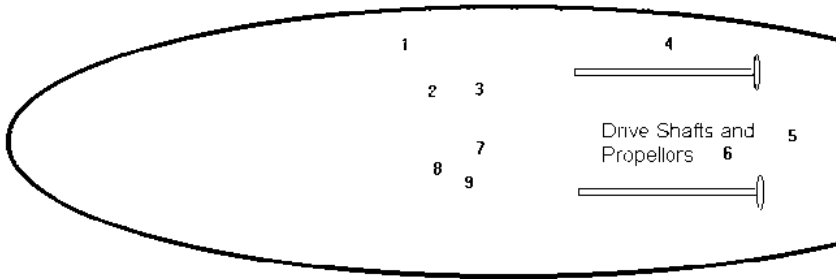
### Below Waterline

LOCATION	USE	MATERIAL	TYPE	COMMENTS
1	Head raw water intake	Bronze		GOOD CONDITION SEACOCK opens and closes
2,8	Engine raw water intakes	Bronze Screen, no sea strainers inboard	Screen/Seacock	GOOD CONDITION Hard to get to SEACOCK but opens and closes
3	Macerator discharge	Bronze	Seacock	GOOD CONDITION Hard to get to SEACOCK But opens and closes
4	Transducer	Plastic	Bayonet	GOOD CONDITION
5	Plug	Bronze	Drain Plug	GOOD CONDITION
6	Deck wash down and live well	Bronze	Seacock	GOOD CONDITION SEACOCK Opens and closes
7	Starboard Engine raw water intake	Bronze Screen	Screen/Seacock	GOOD CONDITION Hard to get to SEACOCK But opens and closes
8	Air Conditioning raw water intake	Bronze	Seacock	GOOD CONDITION Hard to get to SEACOCK But opens and closes
