Infrared Thermography and Void Detection in GRP laminates

John (JACK) N. Allinson, II BS
SAMS® Accredited Marine Surveyor AMS®
Level I Certified Infrared Thermographer
J.N. Allinson Associates, Inc.

Abstract:

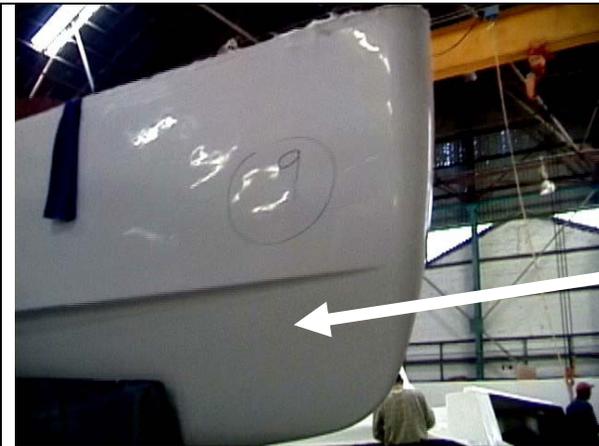
Void in Gel Coat

Exterior surface of the Gel Coat is shiny and uniform. No suspicious signs of deformity or voids in the Gel Coat as seen with the unaided eye.

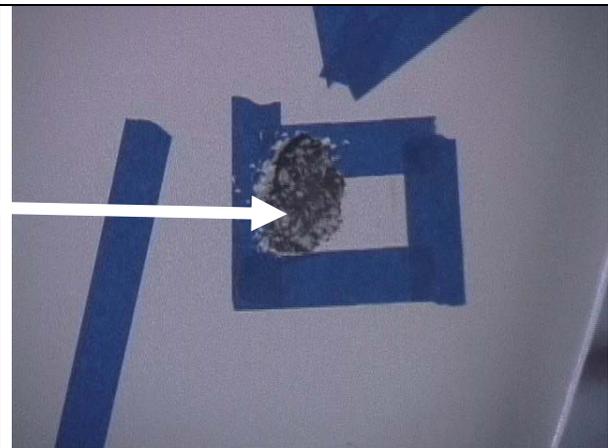
Void in Gel Coat confirmed by percussion sounding followed by grinding it out for repair.
